Subject: **Docket No. 50-362**
60-Day Report
Licensee Event Report No. 2002-001
San Onofre Nuclear Generating Station, Unit 3

FACILITY NAME (1) San Onofre Nuclear Generation Station (SONGS) Unit 3					DOCKET NUMBER (2) 05000-362		PAGE (3) 1 of 6				
TITLE (4) Loss of Offsite Power With Consequential RPS/ESF Actuations Due To Maintenance Error											
EVENT DATE (5)			LER NUMBER (6)			REPORT DATE (7)			OTHER FACILITIES INVOLVED (8)		
MONTH	DAY	YEAR	YEAR	SEQUENTIAL NUMBER	REVISION NUMBER	MONTH	DAY	YEAR	FACILITY NAME	DOCKET NUMBER	
2	27	2002	2002	001	00	4	24	2002	FACILITY NAME	DOCKET NUMBER	
OPERATING MODE (9)		1		THIS REPORT IS SUBMITTED PURSUANT TO THE REQUIREMENTS OF 10 CFR §: (Check all that apply) (11)							
POWER LEVEL (10)		100		20.2201(b)		20.2203(a)(3)(i)		50.73(a)(2)(i)(C)		50.73(a)(2)(vii)

Plant: San Onofre Nuclear Generation Station (SONGS) Unit 3
Event Date: February 27, 2002

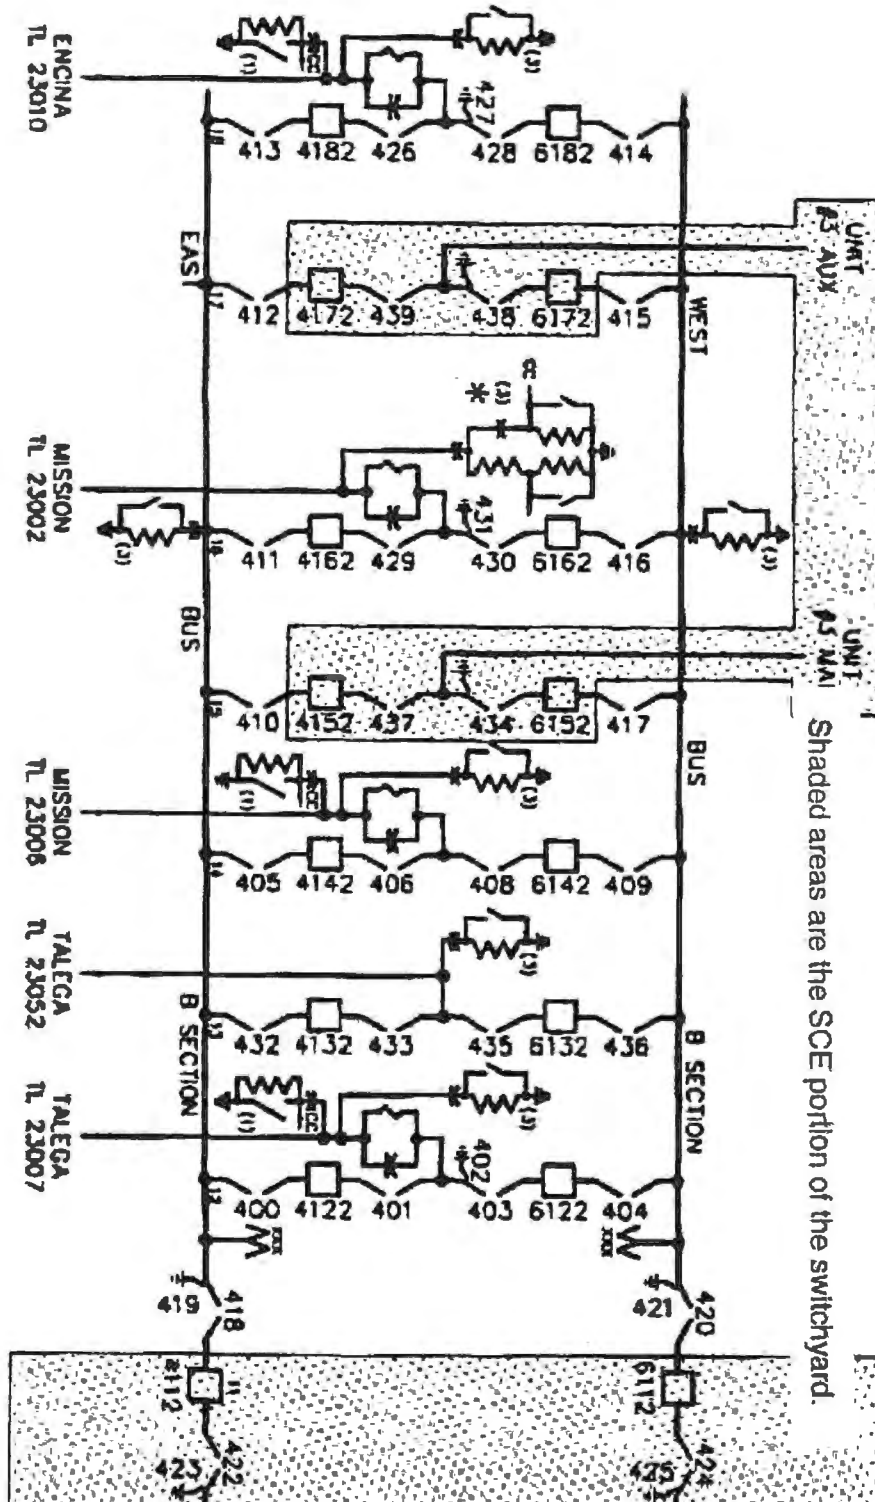
Figure 1 - SONGS Switchyard

Features of the San Onofre (SONGS) Units 2 and 3 electrical distribution system include the following (See Figure 1):

the work, the "South West" bus was de-energized. All the transmission lines from SDG&E territory, Unit 3 RATs, and Unit 3 main transformer (main generator) were aligned to "South East" bus. The SDG&E technician's approved work scope was to test the Breaker Failure Local Backup (BFLBU) scheme on the South West bus breakers (i.e. breaker 6122). The technician completed the testing on the circuit for breaker 6122, then chose to test the cross bus BFLBU trip from breaker 4122, located on the South East bus. While doing so, the technician incorrectly generated a signal for breaker 6122 from breaker 4122, actuating the South East bus breaker failure scheme. This signal tripped all the breakers connected to the South East bus, including the Unit 3 main transformer breaker and Unit 3 RAT breakers (AR020201440). The following consequential events occurred at Unit 3 (unless otherwise stated):

This event was caused by cognizant personnel error. The technician performing switchyard testing exceeded his authorized work scope (the authorized clearance boundary) and decided to conduct breaker trip testing of the cleared breakers. Because the technician also failed to isolate one of the breaker trip signals, when breaker 4122 was trip tested, the South East bus BFLBU caused the South East bus section to isolate. This action then isolated Unit 3 from the grid causing it to trip.

- Offsite power was restored to Unit 3 at approximately 1115 PST the same day;
- Future switchyard detailed work plans will be reviewed and approved by SONGS Operations prior to the commencement of work; and
- This event and its corrective actions will be reviewed with appropriate SONGS, SCE Grid Operation and Maintenance, and SDG&E personnel who work in the SONGS Switchyard.
